**Forces Acting on 1970's Technology Press  
Under NO LOAD.**

**Year 2000 Press Technology – All CNC Machined  
Komatsu Exclusive Plunger Guide**

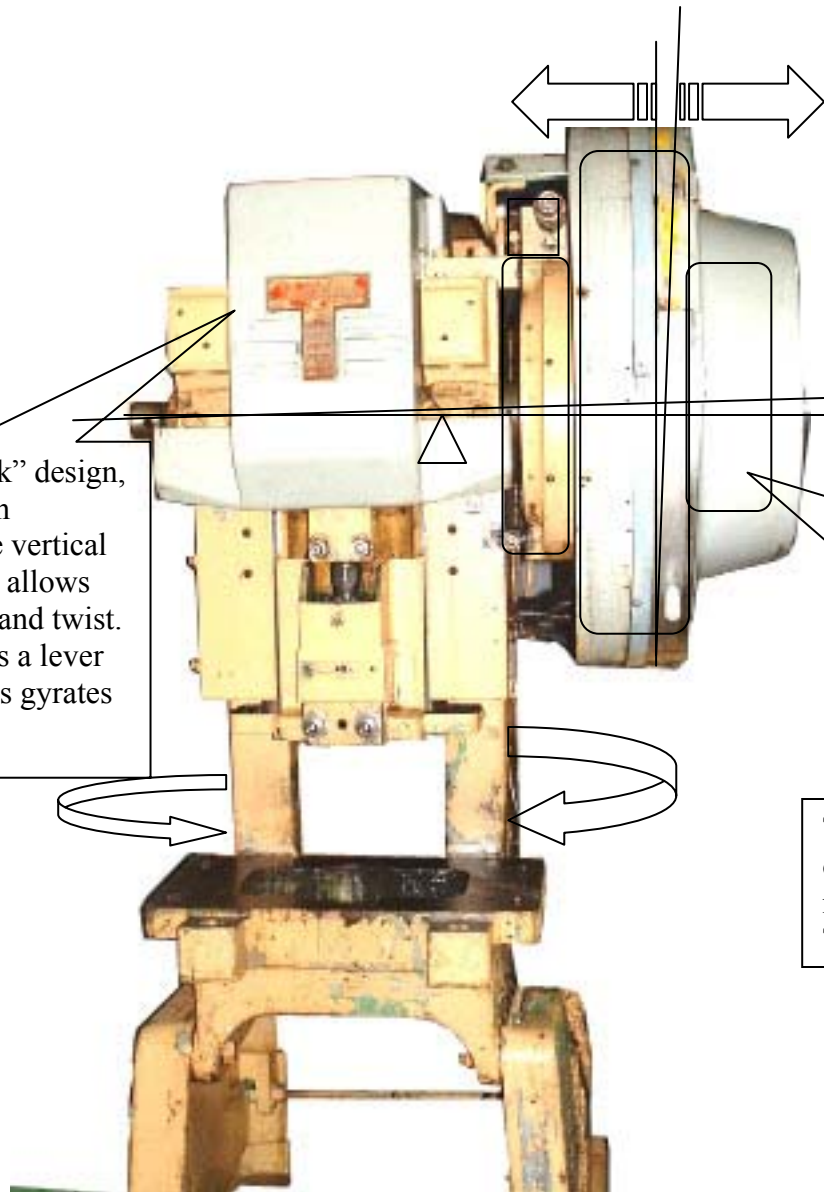
Due to the "open back" design, there is very little iron spanning between the vertical frame members. This allows gib position to move and twist. The crankshaft acts as a lever that flexes as the mass gyrates changing shut height.

The clutch, brake and flywheel are at least 1/3 the press weight. The overhang must cause the crankshaft to sag. As the flywheel turns, the mass must oscillate, flexing the crankshaft and deflecting the supporting frame members. The mass cannot be made with perfect balance causing added deflection to the frame members.

The flywheel releases energy to make the part. Up to 10% of the RPM is used during the bottom 1/16" of stroke. The motor "recovers" this RPM prior to making the next part. The flywheel accel. / decl. dynamics cause frame deflection.

Six Sigma problem identification:  
The flywheel is located where it causes an unbalanced system. Accuracy changes as the mass takes the machine for a ride.
